THE VIKING PIPER

DESIGN, CONSTRUCTION AND OPERATION

Authors: Bart Boon and George Lagers
with support of the Gusto History Group

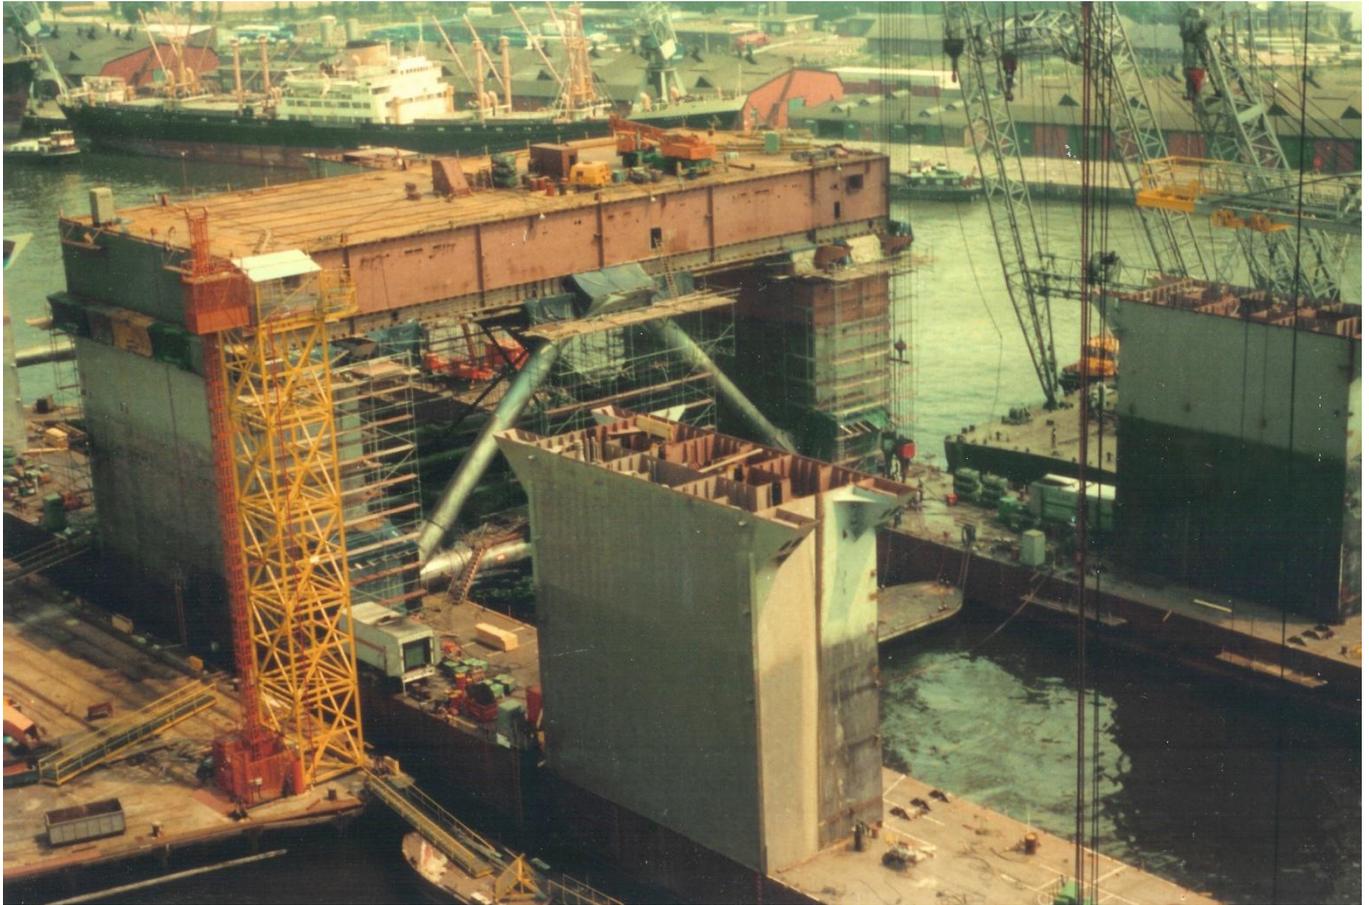
Figure 5 Floaters, columns, bracings and upper deck section

maximize the allowable pipe load on the deck. These considerations led to rectangular columns sitting on the outside of the floaters (Figure 5).

Another special feature of *VP* was the lack of any brackets in the transition of columns to floaters (Figure 1). Again it was felt that this was justified in view of the good structural continuity at this point. Although it was recognized that some stress concentration might be caused, for instance in the plane of the outer float and column shell, it was also expected that any bracket in the corner would make the stress transfer between column transverse shell and bulkhead in the floats less effective. Nevertheless at the upper end of the columns large box-type brackets are provided in the transition to the upper pontoon structure. It was recognized that the upper pontoon would be more flexible than the floats in view of its smaller depth (5.95 meters as opposed to 8.25 meters). If brackets were to be provided, they would for that reason be more advantageous at the top end of the column than at the lower end. But the main reason to provide these box brackets was supporting the deck blocks in between the columns during assembly, as long as those blocks were not yet rigidly welded to the blocks above the columns. Figure 5 illustrates this situation.

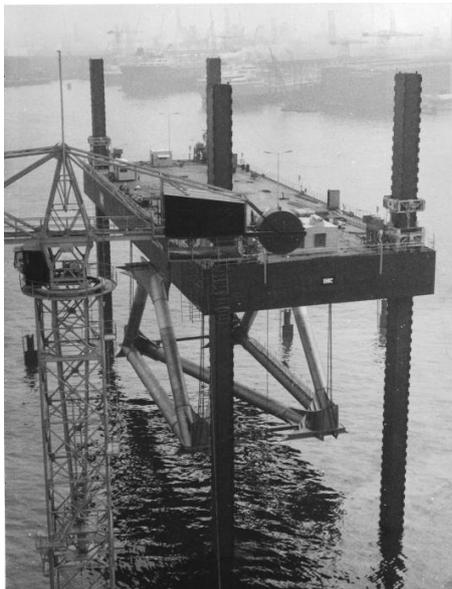
Figure 10 Setting a bracing assembly

doing so all bracing members between two columns could be pre-assembled and lifted by the *Assembler I* as one unit (Fig. 10) making assembly of the vessel easier. During the feasibility study¹⁵ the horizontal braces were laid out as in Figure 11. In the preliminary design stage it was suggested to replace the horizontal X-braces with K-braces. This would make the braces more efficient (a better angle for accommodating any horizontal shear force between the two floats) and result in less complex nodal points. This was rejected by client and management “because everybody knows X’s are more efficient than K’s”. In combination with the transverse bracing lay-out of Figure 9 the diagonal horizontal braces were laid-out as in Figure 12. Note that raising the lowermost braces made the horizontal diagonal braces less efficient due to their direction.

The Assembler 1 (Fig. 10, 28) was placed in the water on its legs in a position close to the yard's quay. At each assembly operation, the deck of the platform was jacked up high enough to allow a deck block, or other piece of equipment, to be floated in underneath. After attaching the deck block to the platform deck, platform and block were jacked up to give a clearance of 25 to 30 m between water and deck. At the start of the jacking procedure, the green pin shackles and lifting lugs were tested at an overload, in some cases nearly 100%, by releasing the load on two diagonally opposed legs of Assembler 1.

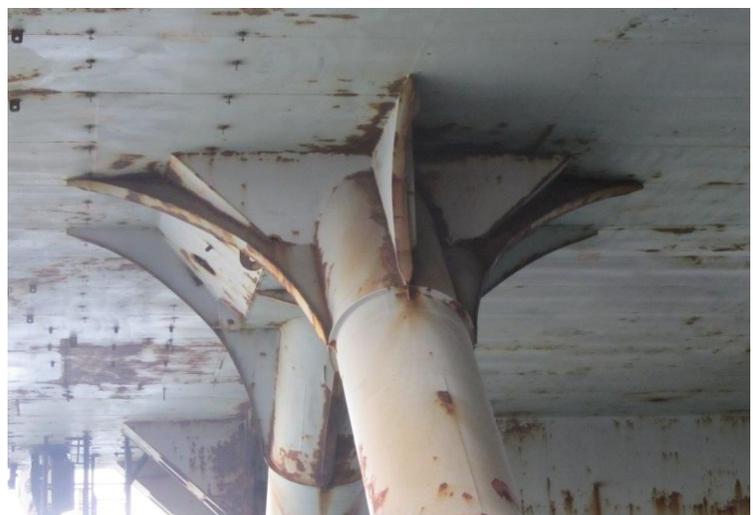
Figure 16 Brace top box in 2012 (Bart Boon)

This principle was also applied at the top boxes connecting the braces to the upper pontoon (Figure 16). Even the additional brace at frame 12 was connected to the float in the same way. For the latter it may be wondered whether for instance the horizontal brackets at some 1.5 meters above the float deck fulfilled any function. This was done as well during the design. However, as there was no way to quickly analyse this (see the finite element analysis described hereafter) it was decided that adhering to the same principle in the design was the most secure way to go.

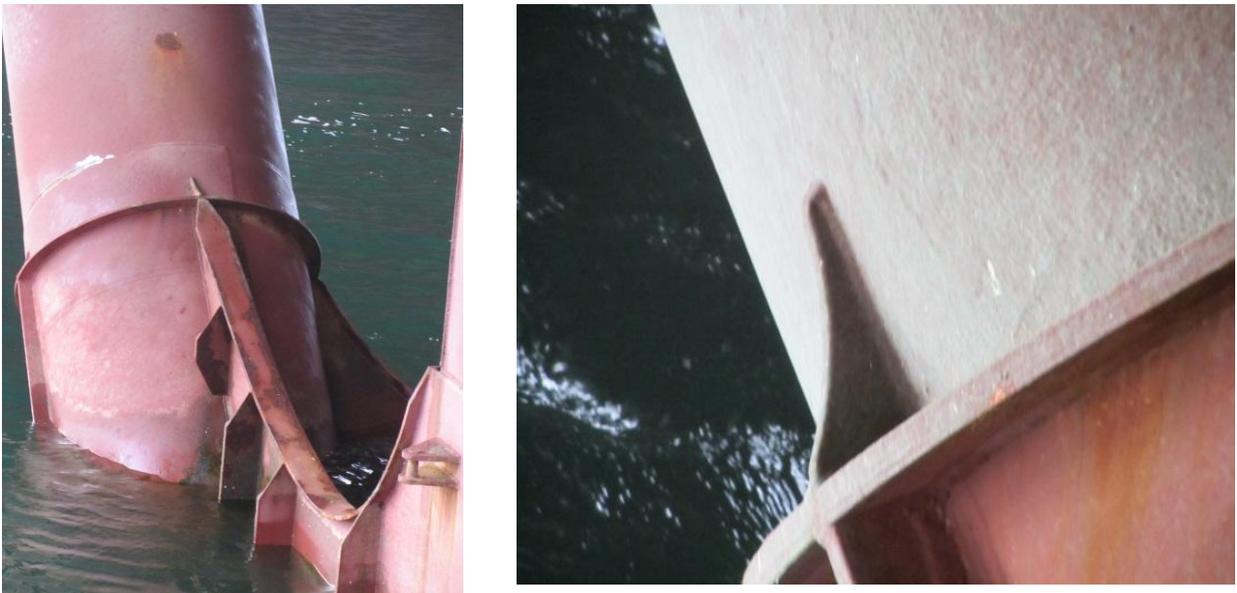
Figure 17 Nodal points on Castoro 7 in 2012 (Bart Boon)

The other nodes had to be based upon the assumption that similar stress concentration factors would apply. It was found that notwithstanding the extreme gradual introduction of the brackets, still some serious stress concentration occurred at the bracket toes. As this meant high stresses at a point of a non-stiffened round plate (a fundamental horror to shipbuilders in view of fatigue initiation) it was decided to provide ring stiffeners on the outside and on the inside of the tubes at the bracket toes. Further FEM analysis still showed quite high stresses, now in bending of those rings. Providing very small triangular brackets in line with the large brackets too away practical all those stresses. Of course those small brackets again ended on an unstiffened plate, but this was considered acceptable in view of their only 15 mm thickness and the fact that they were fillet welded rather than the full penetration of all other welds. The fact that today there is not the slightest indication of any fatigue cracking at these points (Figure 17) shows how effective the original design was.

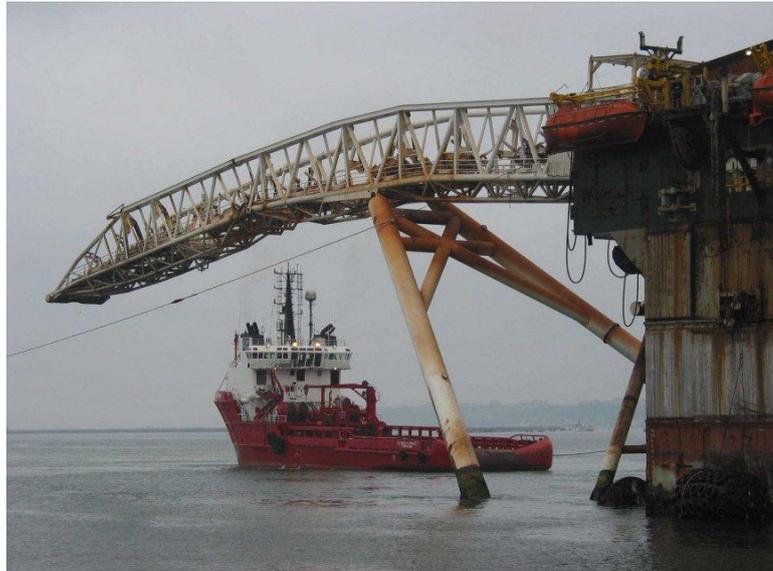
Figure 23 Stern Ramp elevated

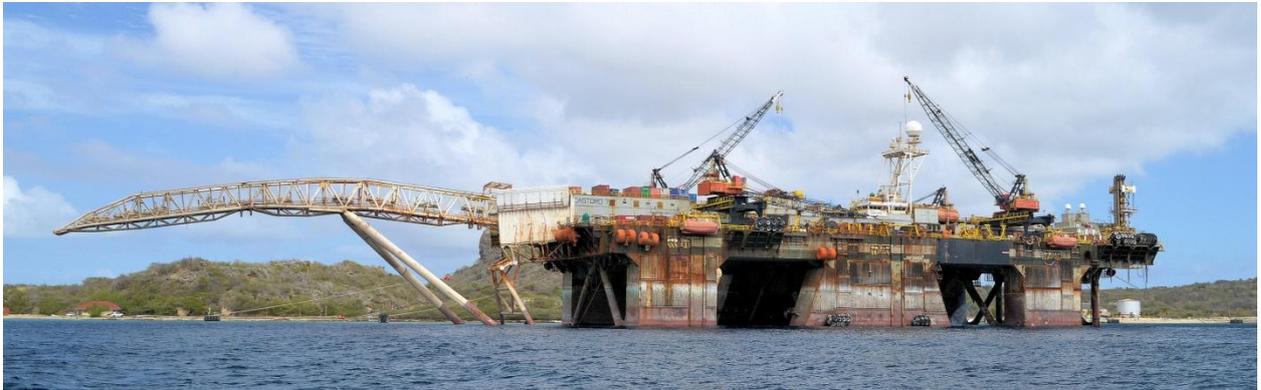
Figure 24 Castoro 7; mark the mid column modification

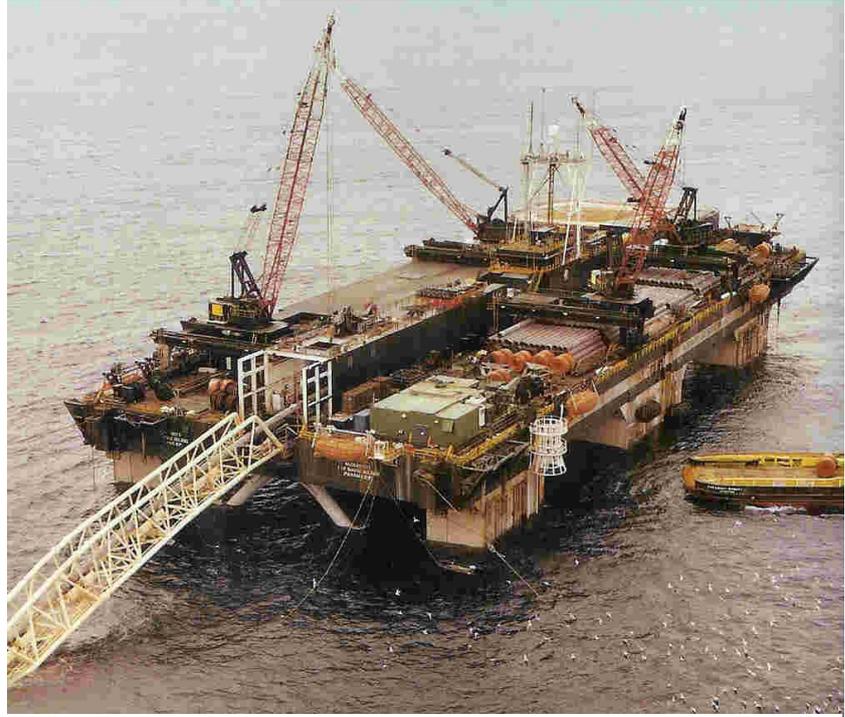
Figure 26 Workdeck in reality

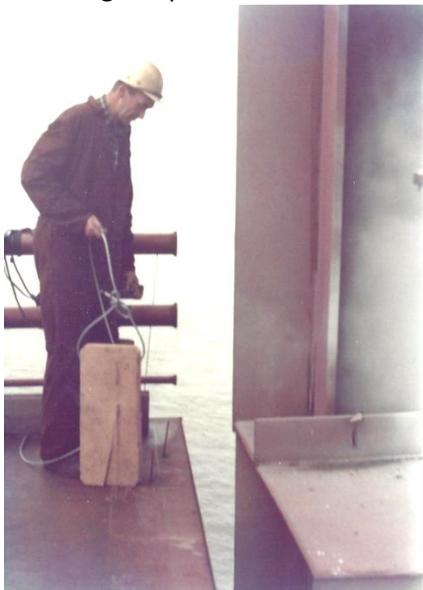
Figure 34 Wood buffer block to prevent damage

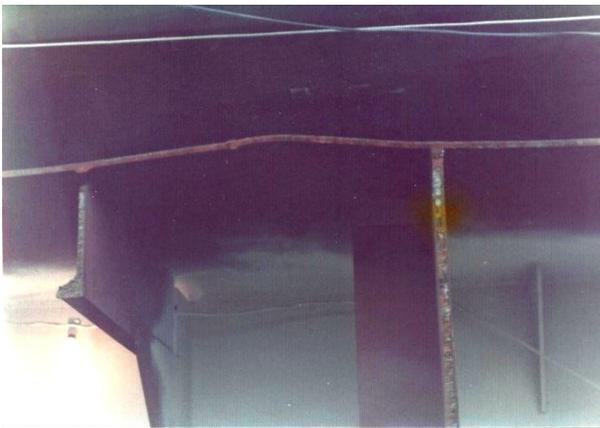
Figure 36 Buckle in block 69

The weakest point was identified at a manhole and indeed there a buckle occurred. Everybody was prepared for this and the procedure simply went on. Repairing this buckle was relatively easy and cheap.

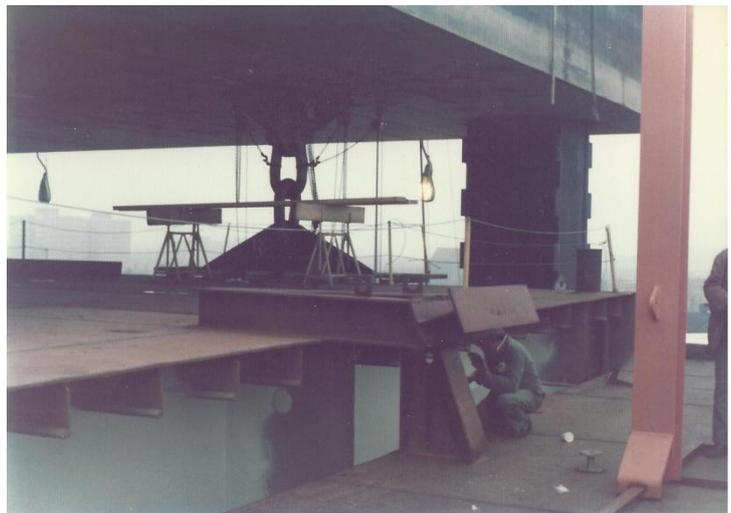
Figure 39 Guiding a deck block into position

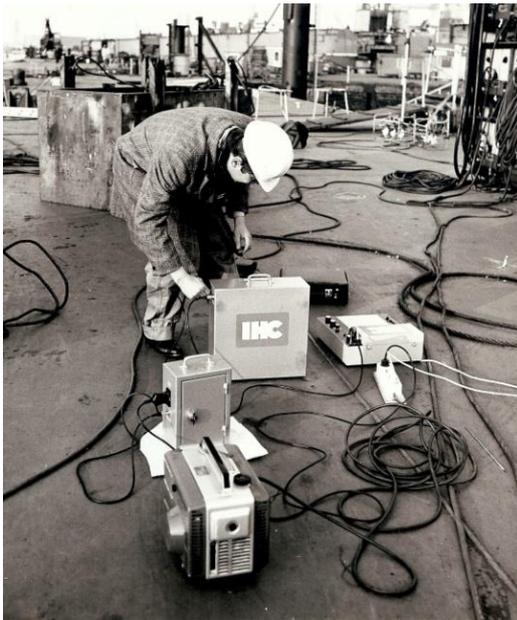
Figure 40 Measuring the heel caused by the column set-down

The floaters arrived at the yard early 1974. First assembly was lifting the midship columns onto the floaters, which was achieved on 6 April 1974. Since they were placed in an eccentric position, counterballasting of the floaters was done in preparation of the set down. To double check on weights and ballast, George Lagers had installed an inclinometer and pen recorder on the deck of the floater, see figure 38.

listing slightly. They ran outside and checked the recorder, which was still running and indeed showing a slowly increasing heel of the floater. It appeared that the water ballast inside the floater was flowing back into the side tanks, because after pumping over to counterballast, the valve between the tanks had not been closed. The situation was redressed well before the column could slide off.

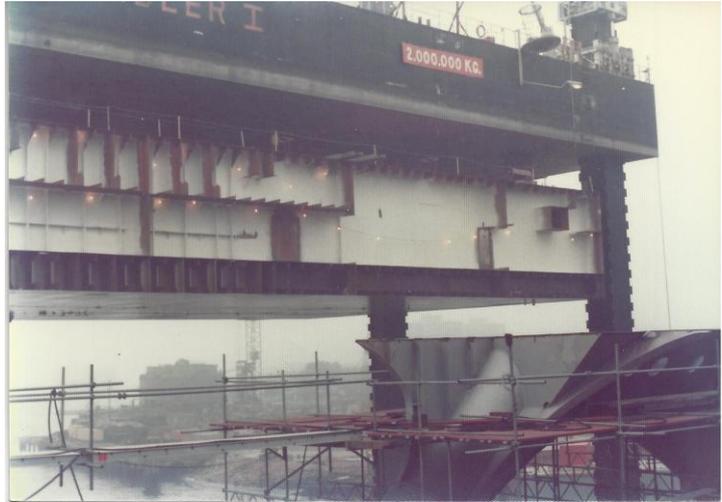
The structural concept of the *Assembler I* took into account the flexibility of the hull.

The platform was designed and built in accordance with Bureau Veritas classification rules. In addition the platform being used as lifting appliance in the Port of Rotterdam had to comply with the regulations of the Port Authorities. We called them and obtained their confirmation of compliance. Then they asked what the lifting capacity of the new appliance would be. Hearing 2000 tons, they only said *Oh, Gusto again*. They wished to see the drawings, but did not intend to review them: *Nobody knows better than you at Gusto how to design such thing. Just use the applicable rules of the Havenarbeidsbesluit*⁴³. After checking these rules, the only thing we could use was *Every lifting appliance should clearly indicate its maximum lifting capacity in kilograms*. Hence the large sign on the side of the *Assembler I* saying 2.000.000 kilograms.

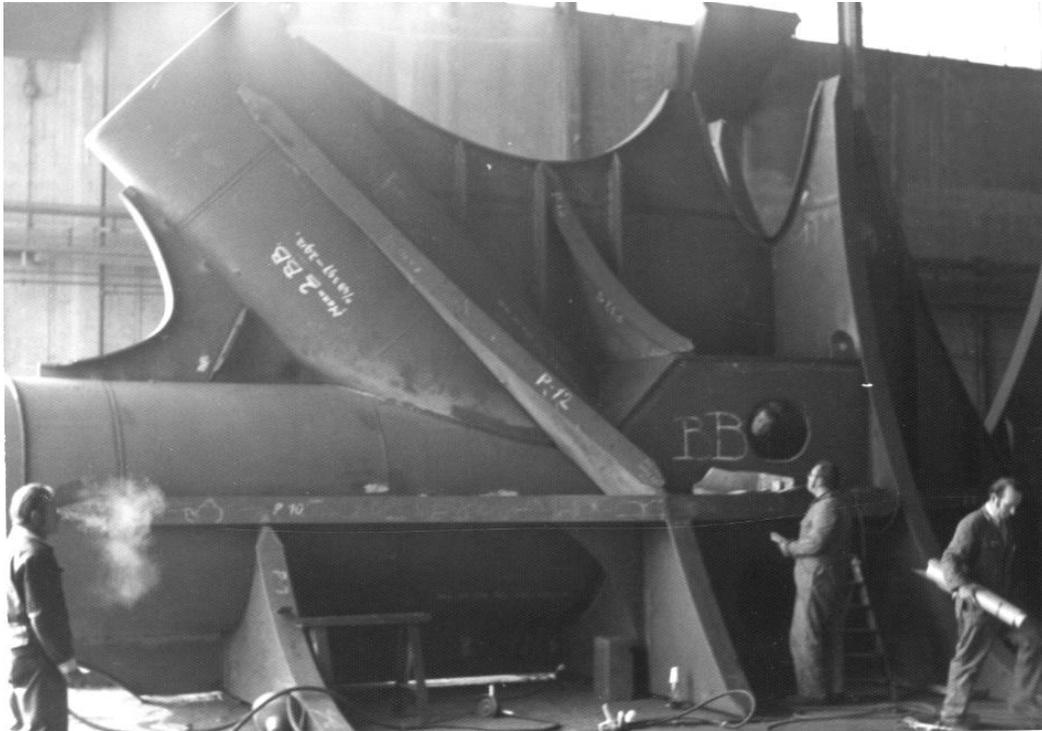
Gemeentearchief Schiedam NL_SdmGA_0386_0318_0137 (GustoMSC)

The bracing blocks in turn were assembled from large units, in particular the brace nodes as shown below.
